House Keeping

Lake Morey Clean Water Community Presentation

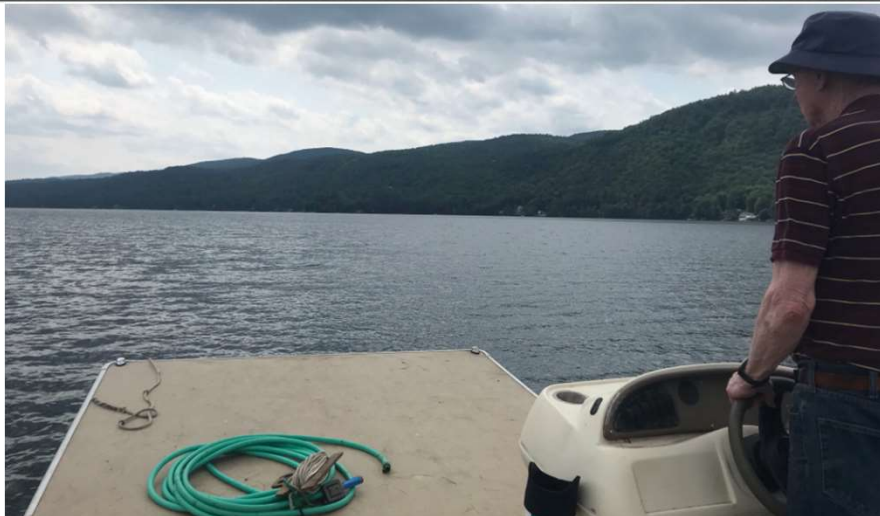
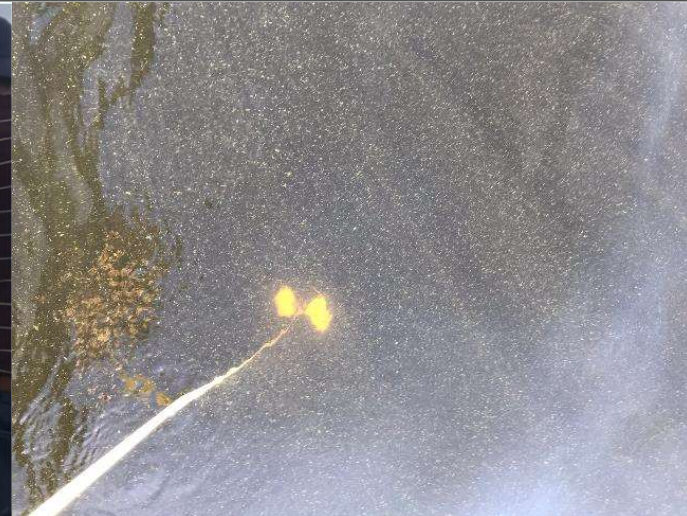
2021 LMP Secchi Depth Comparison for VT Lakes

Average Summer Secchi Transparency for lakes in Vermont and regions of Lake Champlain For 2021

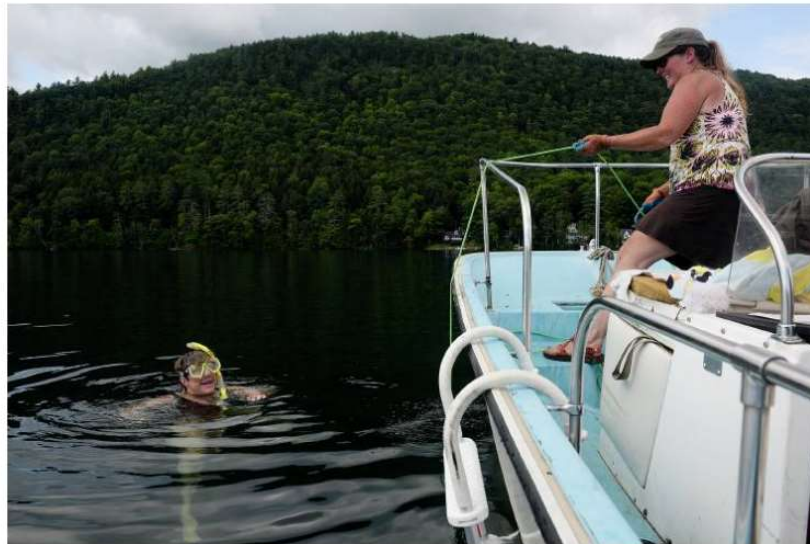
Kellie Merrell, right, drops a sediment core sampler into Lake Morey in Fairlee, Vt., as her fellow Vermont Agency of Natural Resources scientist Leslie Matthews waits in the water to help her retrieve the sample on Tuesday, August 24, 2021. After separating the sample into layers, they can count the number of organisms called diatoms under a microscope to see changes over time. (Valley News - James M. Patterson) Copyright Valley News. May not be reprinted or used online without permission. Send requests to permission@vnews.com. Valley News photographs — James M. Patterson [Buy this Image](#)

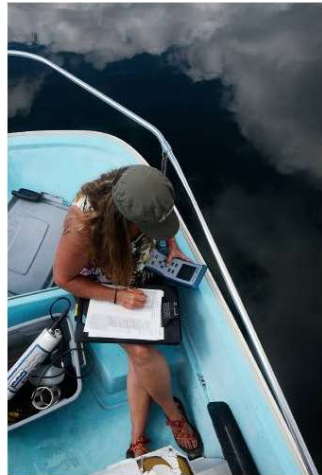
Kellie Merrell, an Environmental Scientist with the Vermont Agency of Natural Resources, records data from a sensor dropped to the bottom of Lake Morey in Fairlee, Vt., Tuesday, Aug. 24, 2021. The sensor relays data including the temperature, pH, conductivity, and the amounts of dissolved oxygen and chlorophyll-a in the water. (Valley News - James M. Patterson) Copyright Valley News. May not be reprinted or used online without permission. Send requests to permission@vnews.com. James M. Patterson [Buy this Image](#)

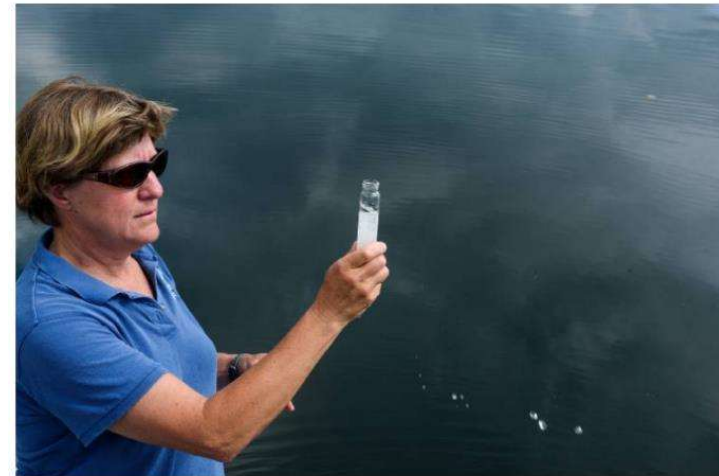
Environmental scientist Leslie Matthews, of the Vermont Agency of Natural Resources, checks the level of a sample of water from Lake Morey in Fairlee, Vt., on Tuesday, Aug. 24, 2021, that will be tested for phosphorus. Matthews and other water quality monitors on the lake are researching rising levels of phosphorus in the lake. (Valley News - James M. Patterson) Copyright Valley News. May not be reprinted or used online without permission. Send requests to permission@vnews.com. [Buy this Image](#)

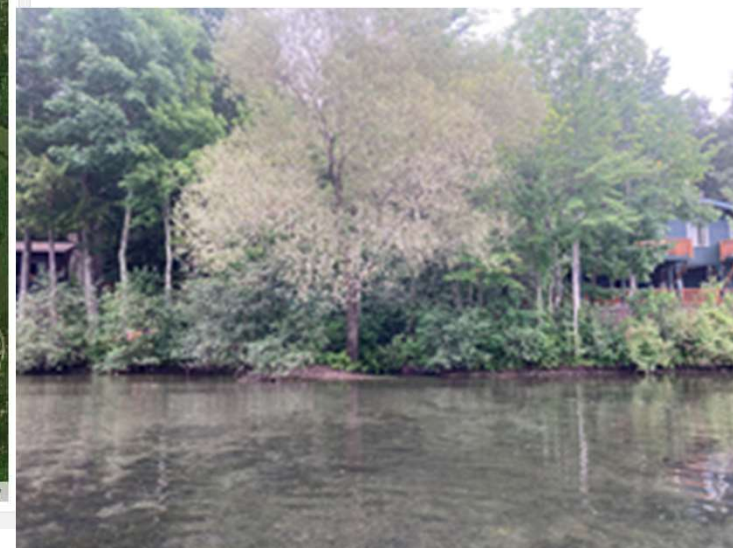
Inlet 9 Delta

InletNo	Sediment Depth (cm)	Sediment Delta (sq meters)	Algae %Cover
1	-1.0	0	5
2	40.0	0	0
3	0.1	3	2
4	2.0	2	2
5	-1.0	0	40
6	-1.0	0	50
7	-1.0	0	10
8	95.0	0	5
9	40.0	6	1
